**VERMILION HARBOR, OHIO
DETAILED PROJECT REPORT
ON SECTION 111
SHORE EROSION STUDY**

STAGE 3 DOCUMENTATION

U.S. ARMY CORPS OF ENGINEERS
BUFFALO DISTRICT
1776 NIAGARA STREET
BUFFALO, NEW YORK 14207

September 1982

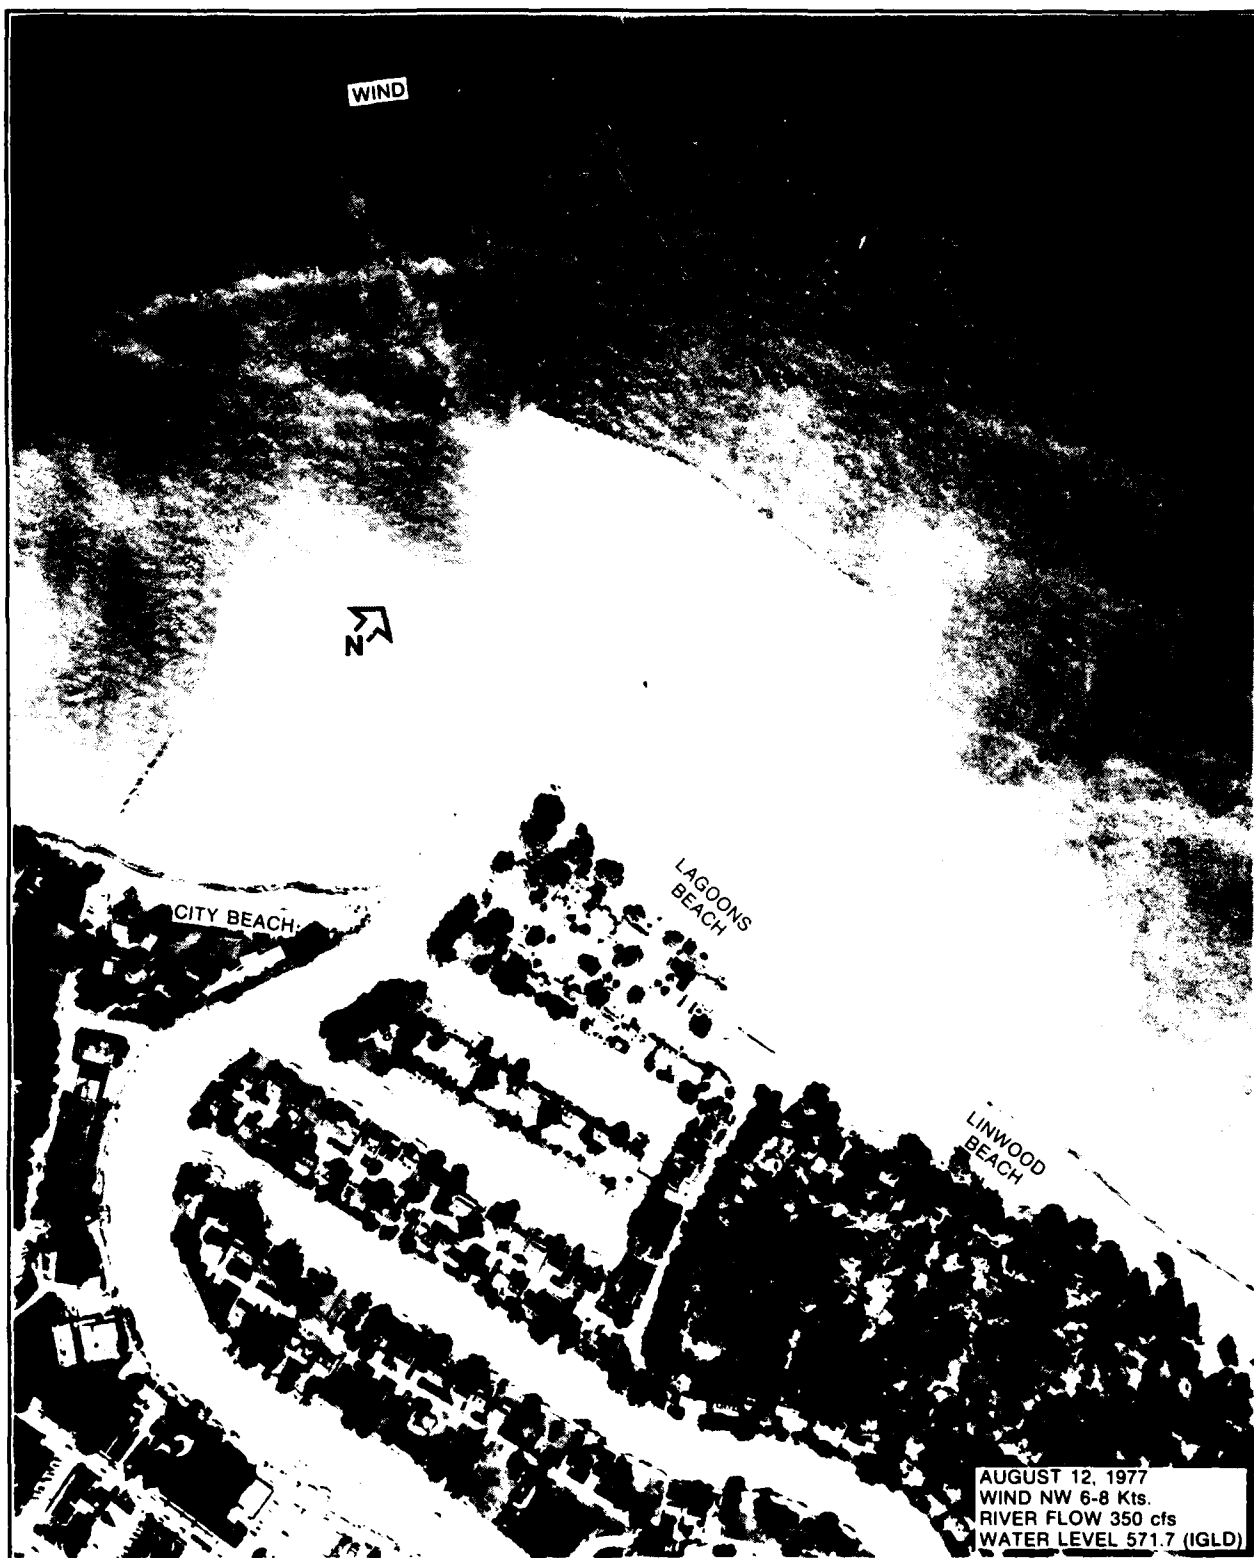
PHOTO 3.1

In recent years, however, the accretion has been greater east of the East Pier. (Photo 3.1). Prior to construction of the breakwater in 1973, the Lagoons Beach immediately to the east of the East Pier was about 200 feet wide. Since construction of the breakwater, this beach has accreted an additional 300 feet, apparently due to the shadowing effect of the breakwater.

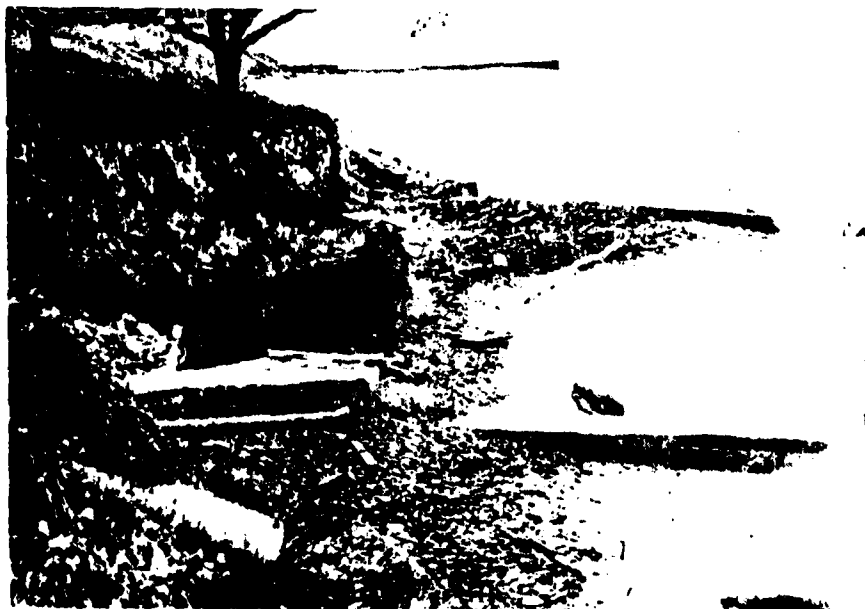
Photo 8 Location "A" Elberta Beach.
Erosion to bluff on the westerly adjoining property.
